Inspection Report

Minerals Regulatory Program

Mine Name: West Side
Operator Name: DJN Rockwalls

Permit number: S/035/0032
Inspection Date: July 20, 2012
Time: About 2:30-2:45 PM

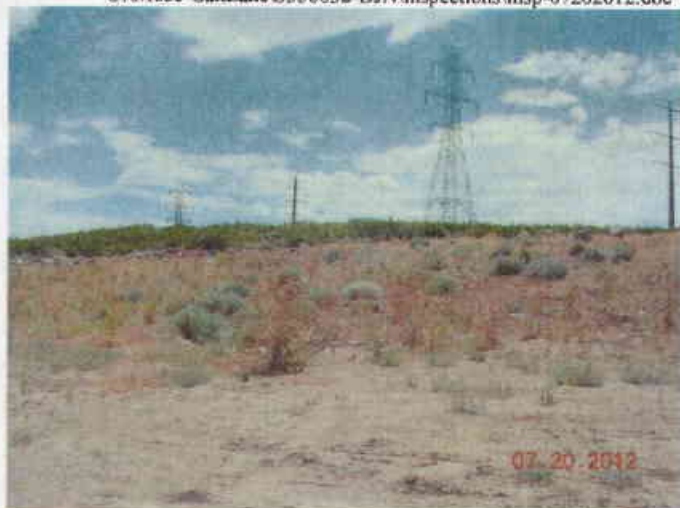
As seen in the attached photos, most of the vegetation consists of weeds, especially cheatgrass, sunflowers, Russian thistle, kochia, and gumweed. There is also quite a lot of Scotch thistle, a declared noxious weed. There are a few perennial grasses and some rubber rabbitbrush.

Photo 1. The four photos show the grading and revegetation. Note the Scotch thistle in this picture.

Most of the undesirable species are either winter annuals or biennials that can be at least partly controlled in the fall. I suggest that the operator wait until there has been some rain and subsequent germination in the fall. Many of the weeds could then be killed either with herbicides or mechanical methods. The area could then be scarified and seeded.

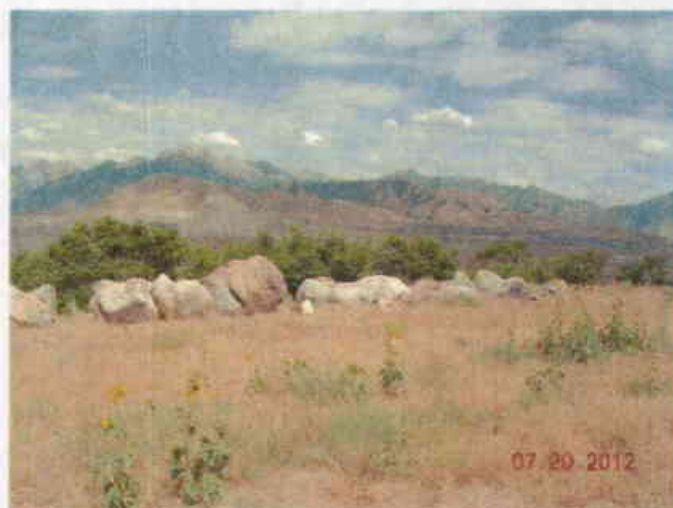
Photo 2. Cheatgrass and sunflowers.

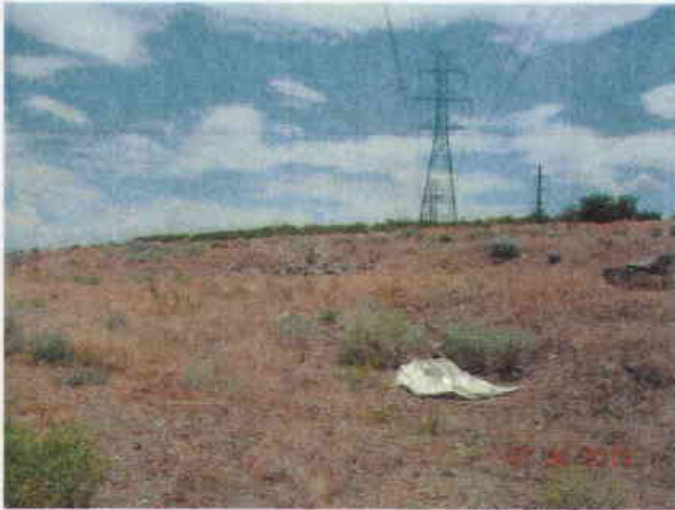
Photo 3. Most of the plants in this photo are cheatgrass, Russian thistle, and kochia, but there is also some Scotch thistle, gumweed, and rubber rabbitbrush.

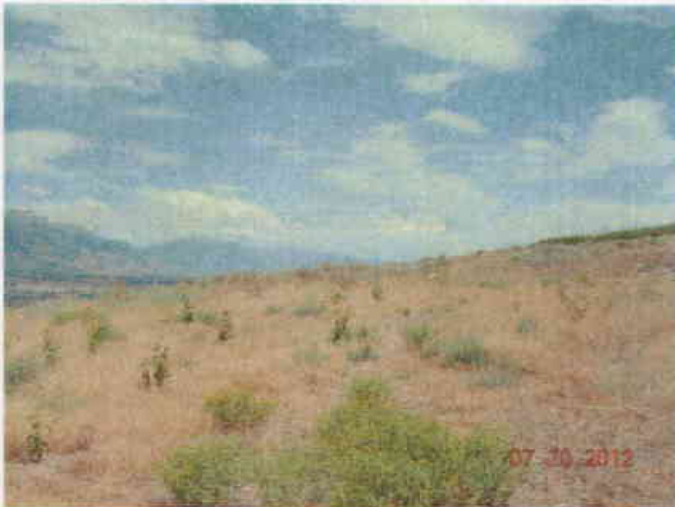
Photo 4. Gumweed in the foreground with cheatgrass and sunflowers.
